**C/o: Three Thousand South Condominium Association, Inc.**

Re: Seawall Investigation (South Section by Pool)

Inspection Date: 3-30-16

Seawall Restoration  
Investigation Photos

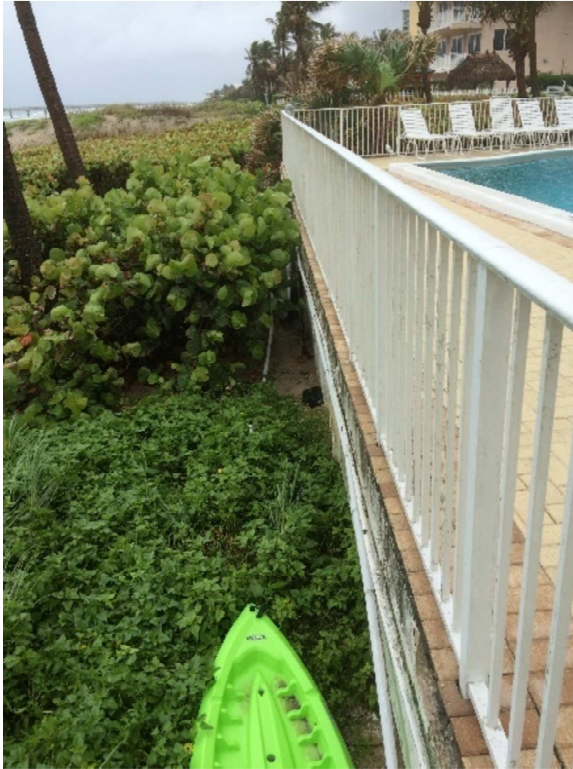
South End of Seawall by the Pool

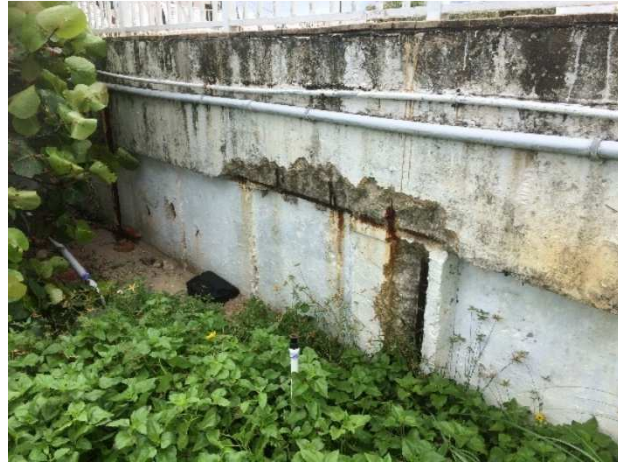
We observed severe corrosion damage and concrete spalling on the seawall cap, piles, and panels. The concrete was weakened and easily broke off. Exposed rebar was corroded with significant loss of thickness.

Severe corrosion damage and concrete spalling on both the seawall cap and panels

It is recommended that the seawall be repaired as soon as possible. The strength of the wall has weakened significantly. The wall acts as a retaining wall holding the weight of the sand and pavers and the weight of the pool.

Repairs will most likely extend through the thickness of the concrete panels all the way through to the back side. This will require the back side of the wall to be exposed by removing pavers and sand. The pool shell is approximately 8 to 10 ft from the wall at its nearest point. It is likely that the pool shell will be affected by the repair work. The trench needed for repairs will be 7 to 9 feet deep and that wide. The pool shell would be exposed on two sides or 50% and may shift due to the likely sand settling and shifting during the excavation process. The pool will also have to be emptied.

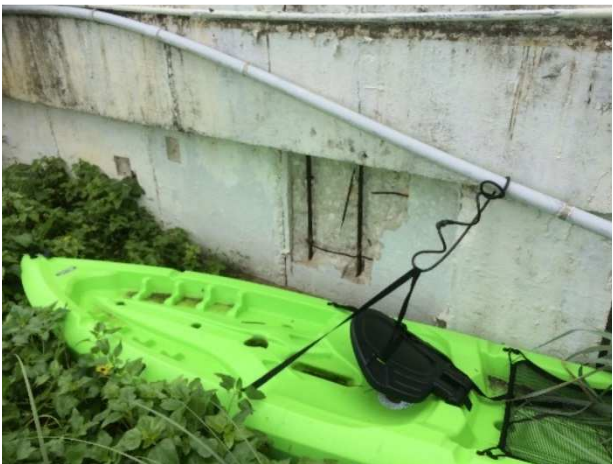
Large piece of concrete had fallen off seawall panel.

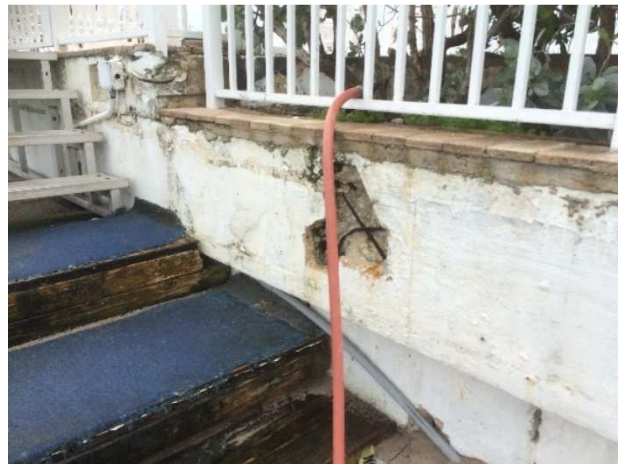
Concrete spalling on the seawall cap.
