Subject: Three Thousand South Ocean Pool Evaluation Report

Sinclair Engineering Company performed a visual, non-destructive inspection of the Three Thousand South Ocean pool and related items in your presence on April 2, 2014.

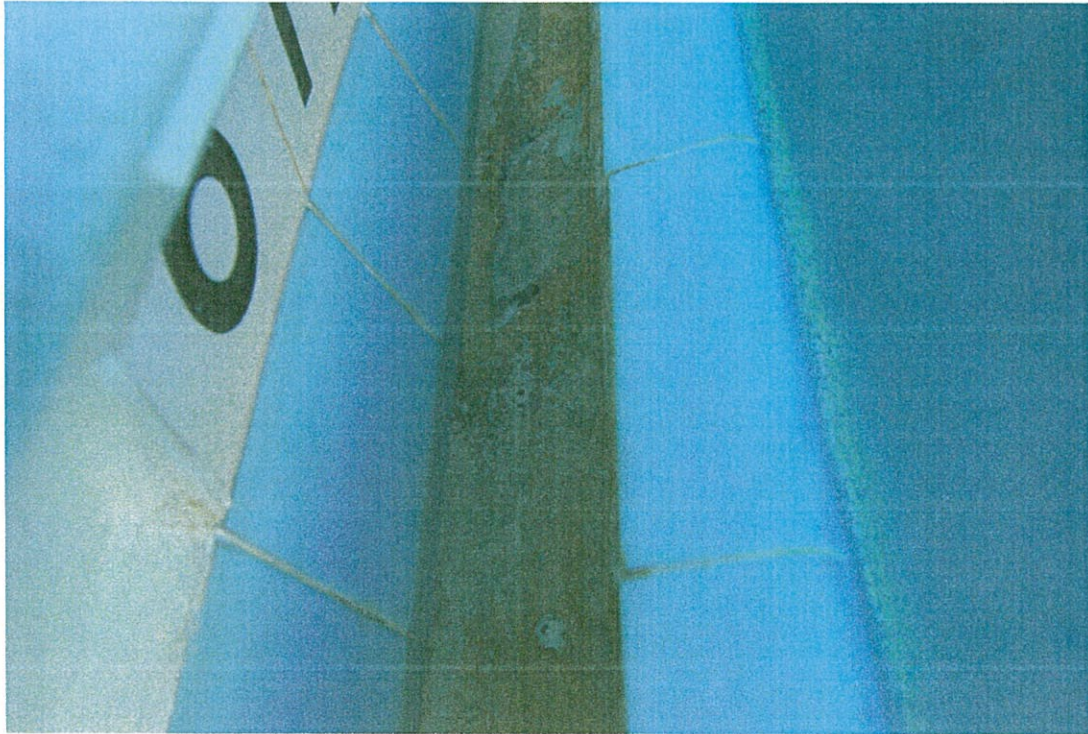
4. Examination of the beam/gutter revealed that it was in generally "fair" condition. Specifically, the finish on the bottom of the gutter trough was eroded away in many locations. Further, gutter drain grates had been installed, one on top of another, which presumably occurred during replacement of the pool finish. It was observed that a number of the grates were broken.

EXHIBIT 3. VIEW OF ERODED BEAM TROUGH FINISH

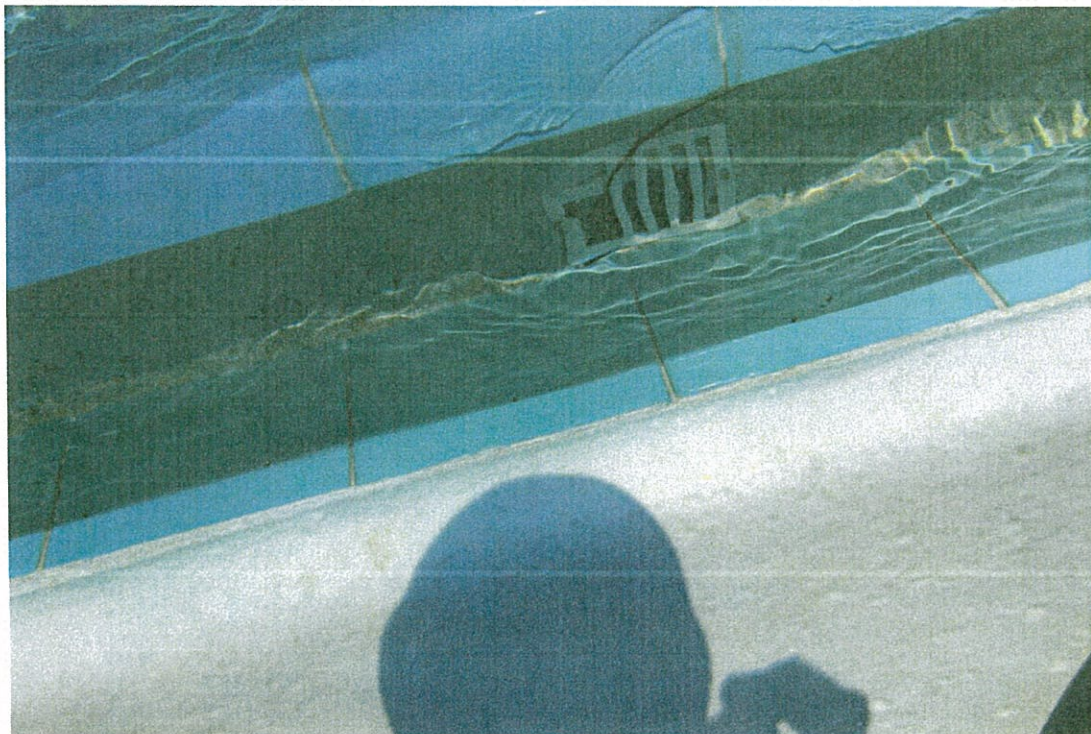
EXHIBIT 4. VIEW OF MULTI-LAYERED AND BROKEN GUTTER DRAIN GRATES

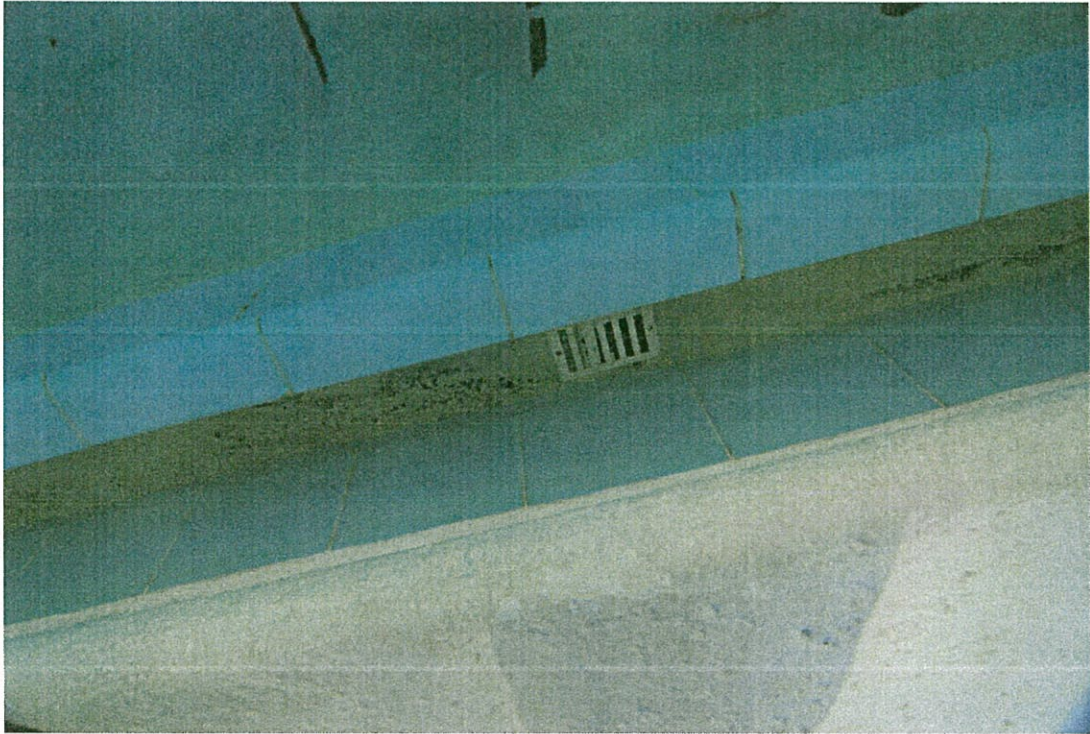
6. Examination of the pool finish revealed that it was in generally "good" condition. That is, there was no visible spalling or discoloration.
7. Examination of the gutter tiles revealed that they were in generally "fair" condition. That is, there were no missing tiles, but there were multiple areas of eroded or missing grout.

EXHIBIT 5. VIEW OF ERODED GUTTER TILE GROUT

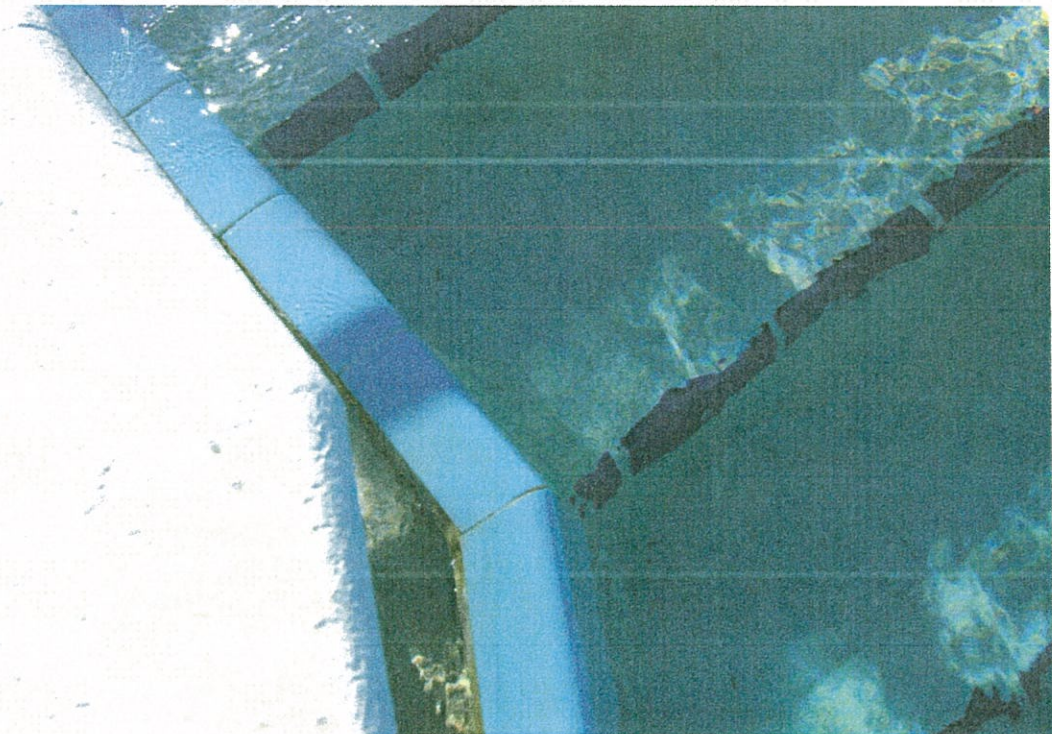
5. Examination of the steps revealed that they were in generally "good" condition, that is, there was no structural damage or unusual deterioration. There were, however, numerous chipped cap tiles at the steps.

EXHIBIT 6. VIEW OF CHIPPED CAP TILE AT STEPS

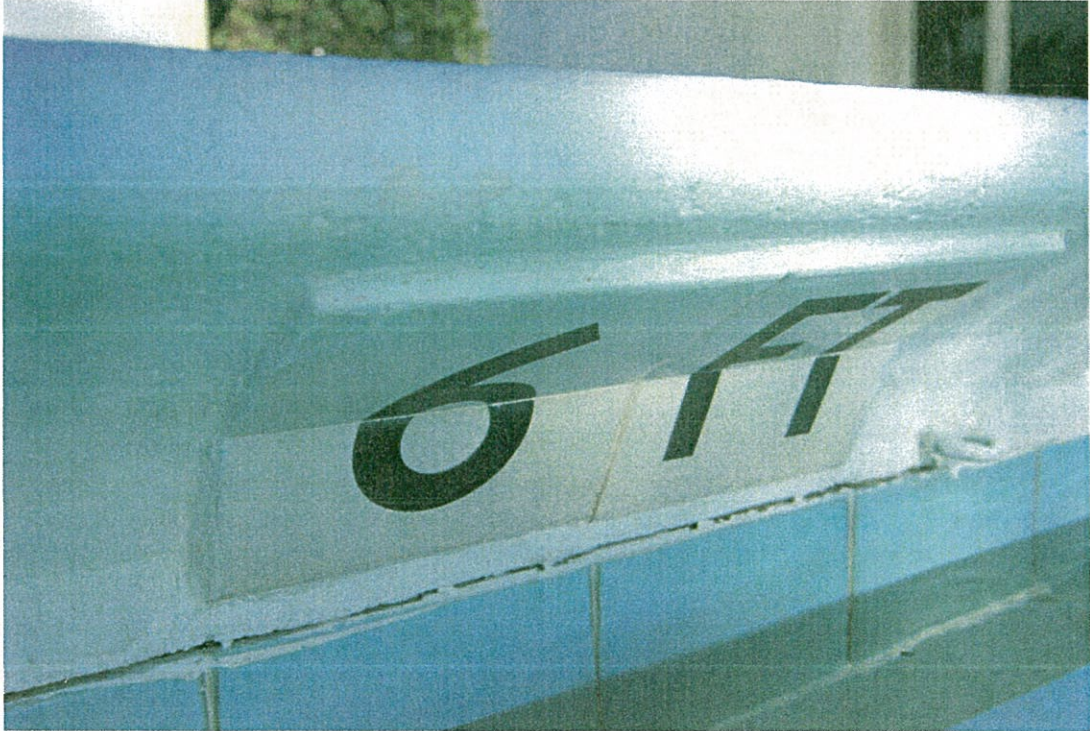
8. Examination of the raised, precast coping stones revealed that they were in generally "fair" condition. That is, a number were loose, specifically, a coping stone at the 6' depth marker had disbonded from the pool beam and lifted. Further, an area of the coping stones adjacent to the steps in the Northeast corner of the pool were "hollow," indicating that they had disbonded from the pool beam. Additionally, there were isolated rust stains in the central portion of the raised coping, but no evidence of cracks in the coping stones in the stained areas.

EXHIBIT 7. VIEW OF DISBONDED COPING STONE

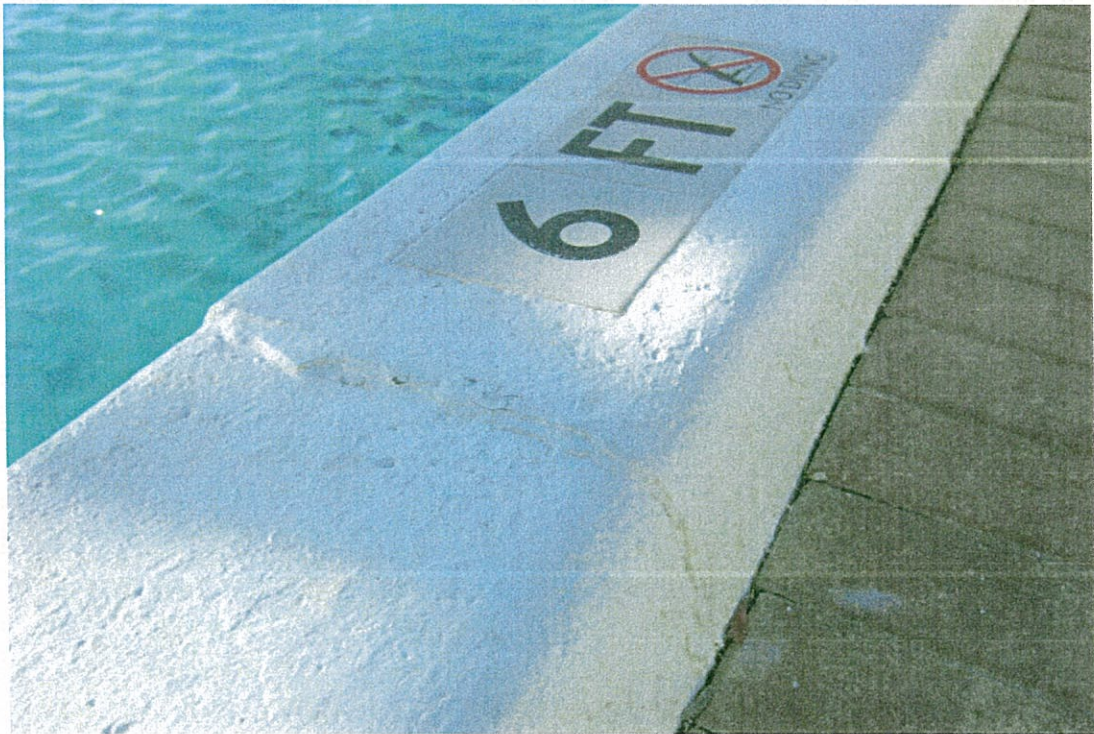
EXHIBIT 8. VIEW OF REPAIRED DISBONDED COPING STONE

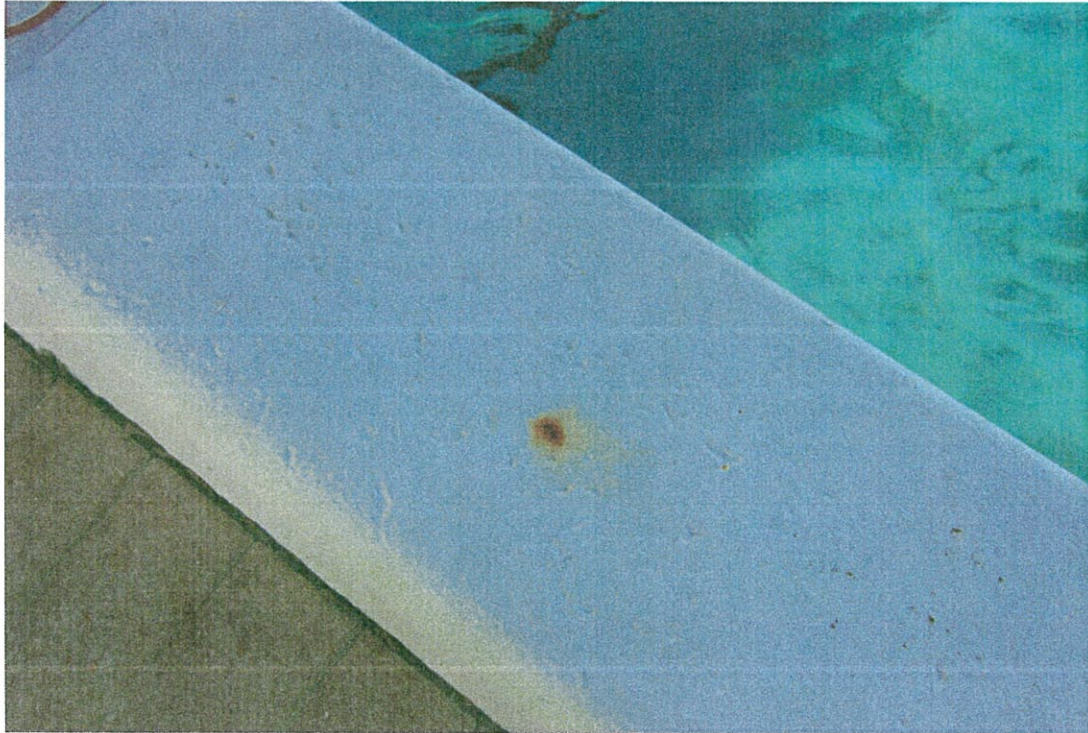
EXHIBIT 9. VIEW OF RUST STAIN ON COPING STONE

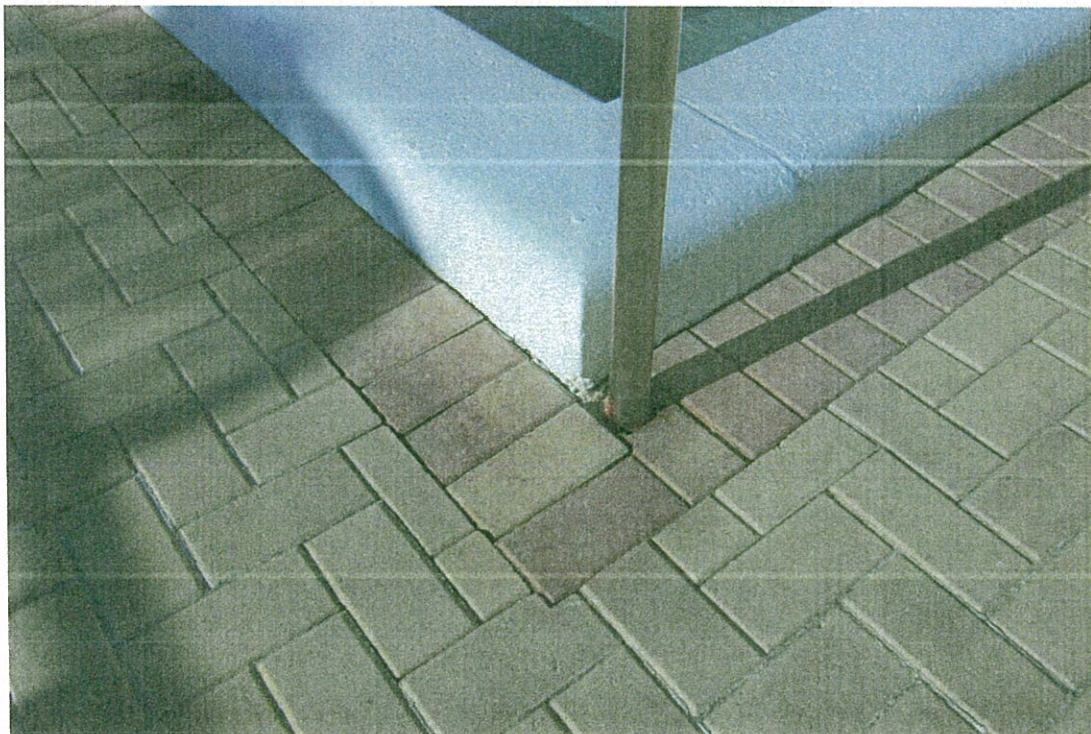
3. The pool deck adjacent to the steps in the Northeast corner of the pool has settled. Additionally, the Southeast corner of the pool appears to have settled unevenly relative to the remainder of the pool. This condition of induced stress on the pool shell could cause crack(s) in the pool shell over time. Soil testing is recommended to determine the condition of the soils underlying the deck and pool.

EXHIBIT 10. VIEW OF POOL DECK SETTLEMENT ADJACENT TO STEPS, NORTHEAST CORNER OF POOL

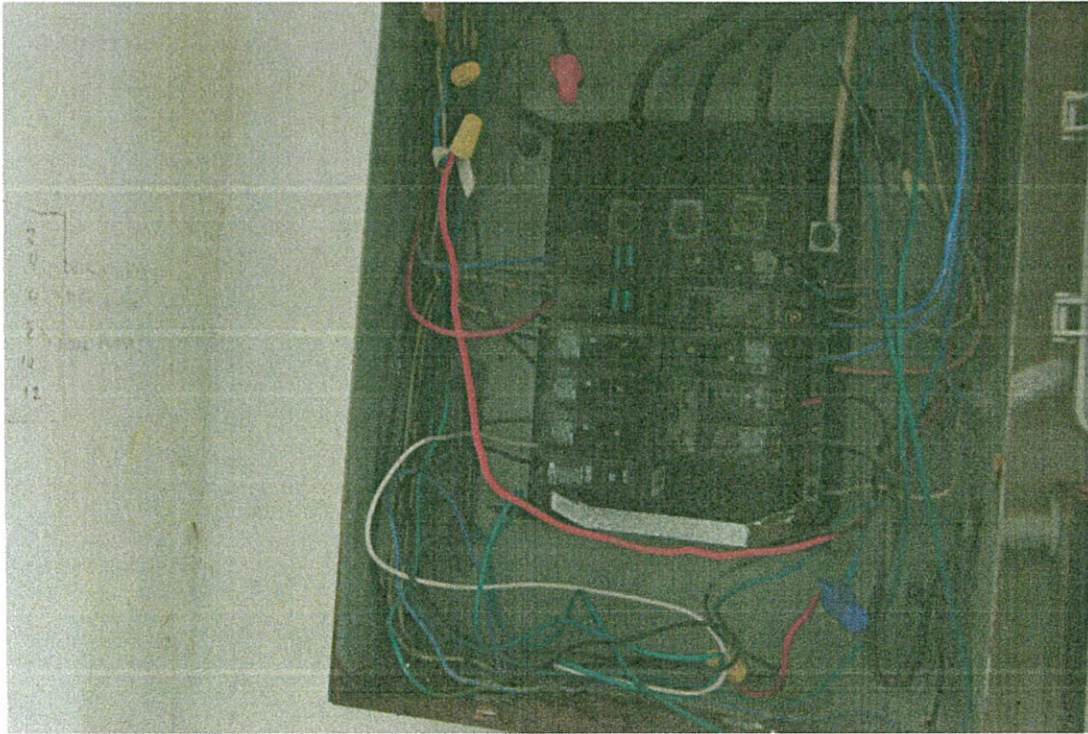
15. Examination of the electrical panelboard in the pool equipment building revealed that several of the wires had been installed in a poor workmanship manner. It was also noted that the panelboard cabinet was corroded.

EXHIBIT 13. VIEW OF ELECTRICAL PANELBOARD IN POOL EQUIPMENT BUILDING

5. The electrical panelboard in the pool equipment building is to be replaced with a code-compliant unit that is installed in a good workmanship manner in accordance with the National Electrical Code and safety standards.

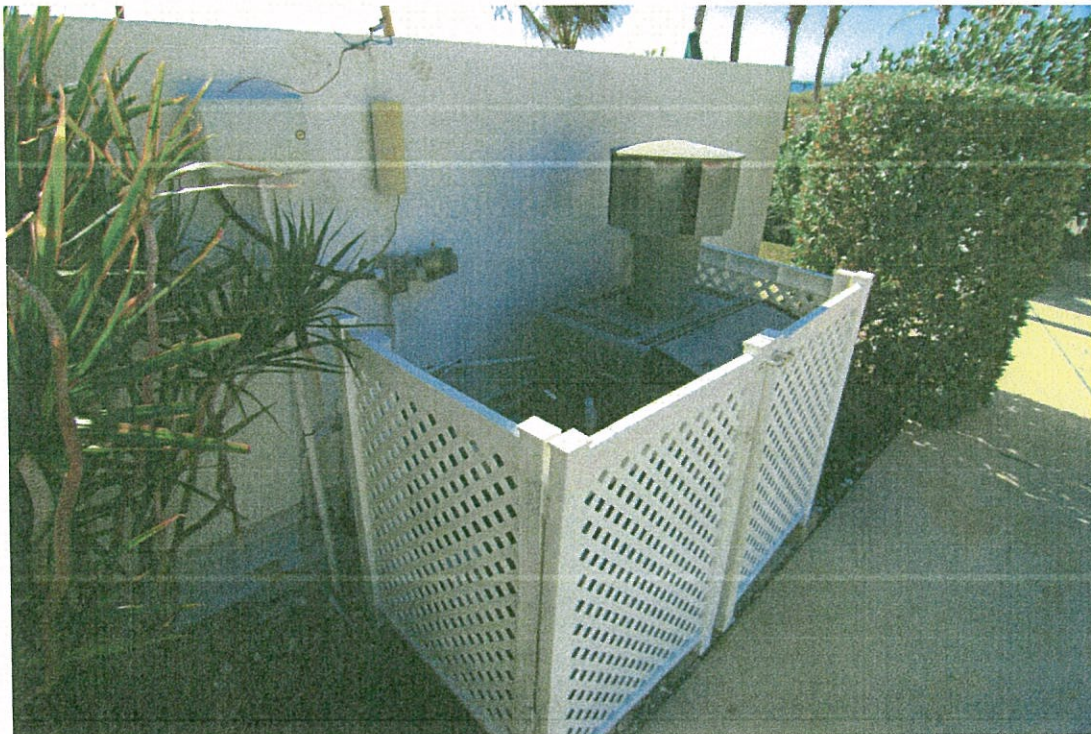
20. Examination of the pool heater, located outside the West wall of the pool equipment building, revealed that it was a Jandy LRZ gas heater. You informed me that the annual expense to heat the pool is in excess of \$20,000.00 (gas bill). You further stated that, due to exposure to salt air, heater replacements were relatively frequent.

EXHIBIT 14. VIEW OF GAS HEATER, WEST SIDE OF POOL EQUIPMENT BUILDING

9. The gas heater is exposed to the elements, resulting in a diminished service life. You indicated that it was costly to operate. A properly designed and sized ground source (geothermal) heat pump should be considered as a replacement to a gas heater. Additionally, this equipment could be used to cool the pool water as needed.

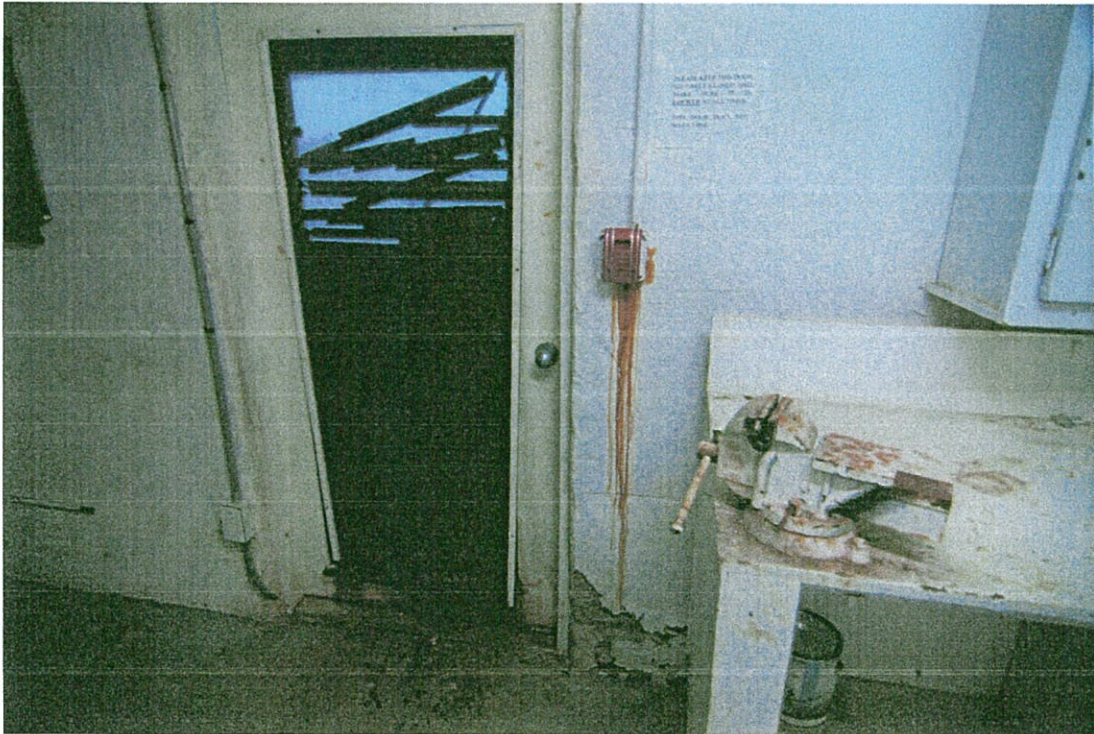
21. Generally, the pool equipment was in "fair" to "good" condition and appeared to be functioning in accordance with the intended purposes.
22. You directed me to an enclosed area at the entrance to the parking garage at the North end of the pool and deck. Examination of the structural components of this area revealed deterioration of the concrete around the pass door opening and deterioration of the pass door.

EXHIBIT 17. VIEW OF DETERIORATED PASS DOOR AND SPALLED CONCRETE, ENCLOSED AREA AT ENTRANCE TO PARKING GARAGE

- e. The spalled concrete at the pass door requires repair and the pass door requires replacement.

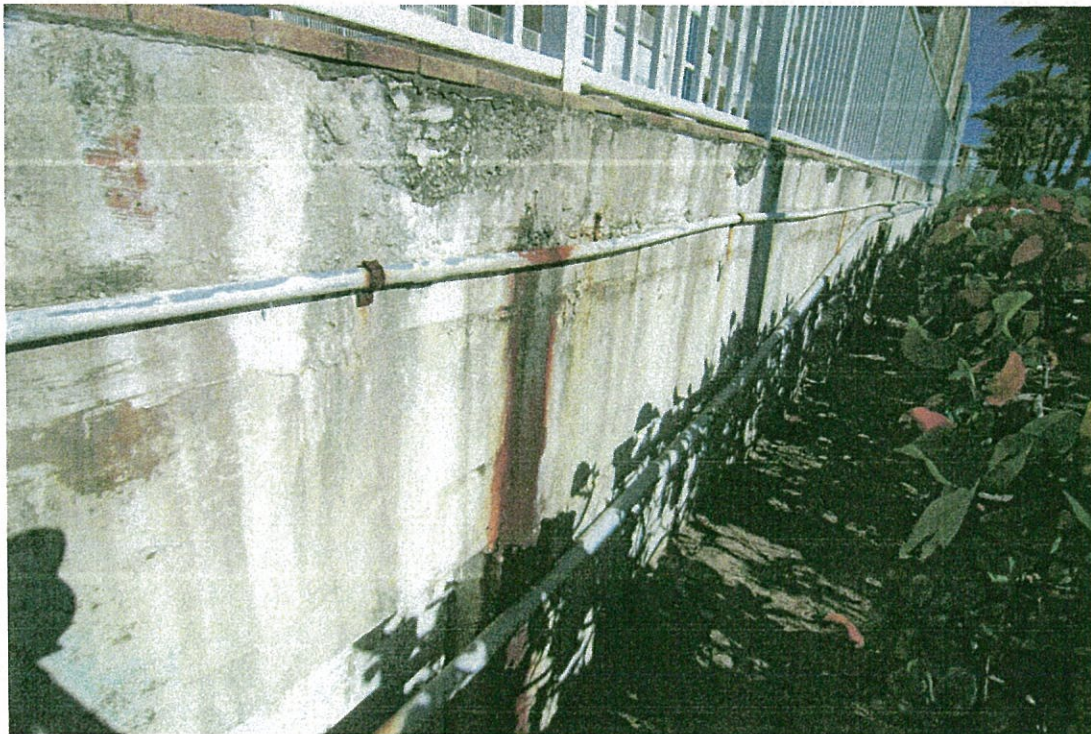
EXHIBIT 18. VIEW OF RUST STAINS ON RETAINING WALL, EAST SIDE OF POOL AND DECK

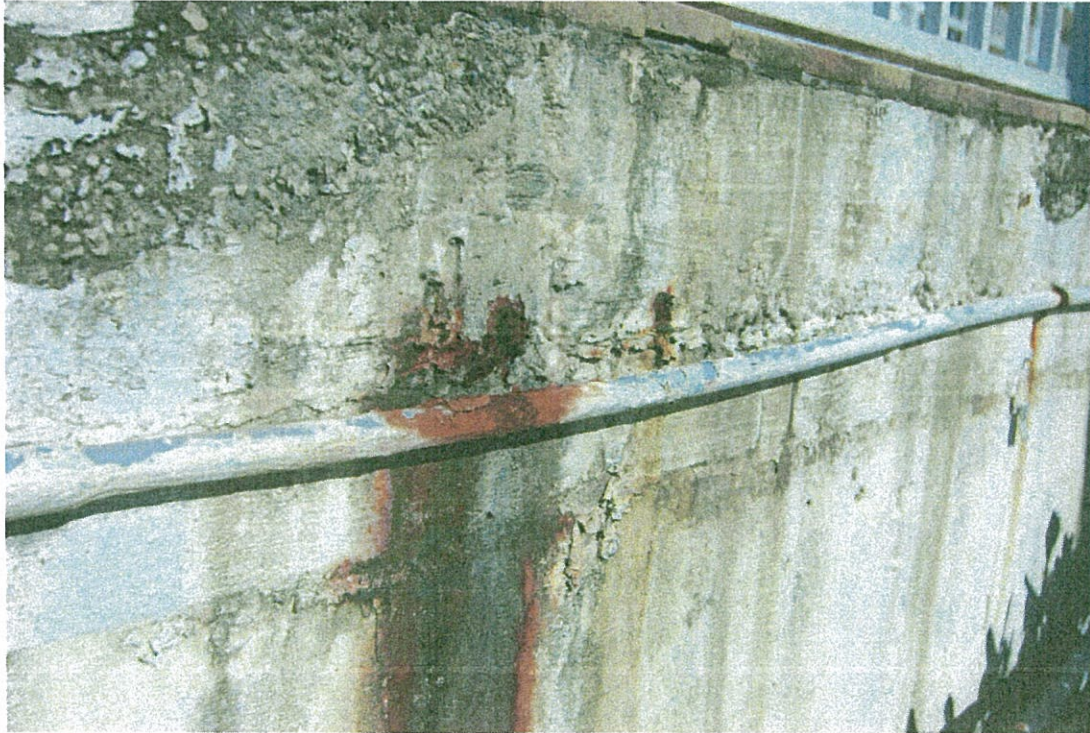
EXHIBIT 19. CLOSE-UP OF RUST STAIN FROM PIPE CLAMP ON RETAINING WALL, REFERENCE EXHIBIT 18

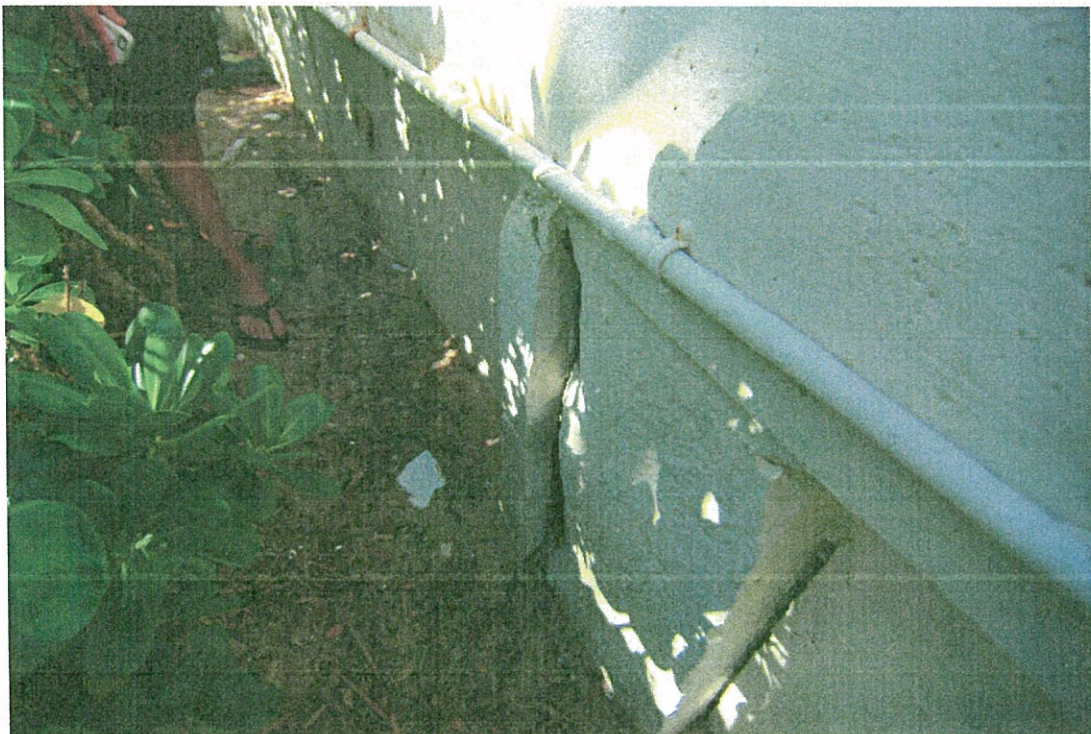
23. Examination of the reinforced concrete retaining wall, along the East and South sides of the pool and deck area, revealed that it was in "good" condition. That is, there was minor surface staining at a pipe clamp. Further, there was spalling / separation of a concrete panel near the steps on the North end of the pool deck area. Close examination of the reinforcing steel in the spalled / separated area revealed that it was severely corroded.

EXHIBIT 20. VIEW OF SPALLED CONCRETE ON RETAINING WALL, SOUTH OF BEACH ACCESS STEPS FROM POOL DECK

16. The retaining wall, located East and South of the pool area, is in generally good condition, except as follows: The spalled concrete panel and corroded reinforcing steel, South of the beach access stairs, are to be repaired in accordance with accepted practices.
