Subject: Three Thousand South Ocean Pool Evaluation Report

Sinclair Engineering Company performed a visual, non-destructive inspection of the Three Thousand South Ocean pool and related items in your presence on April 2, 2014.

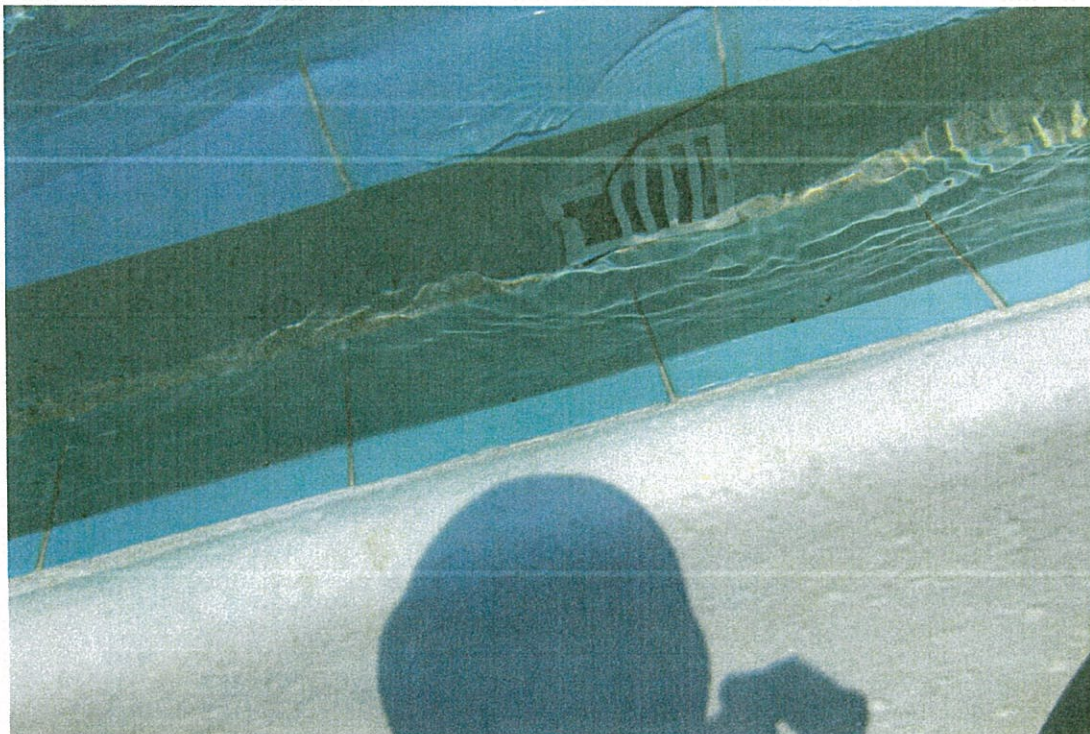
4. Examination of the beam/gutter revealed that it was in generally "fair" condition. Specifically, the finish on the bottom of the gutter trough was eroded away in many locations. Further, gutter drain grates had been installed, one on top of another, which presumably occurred during replacement of the pool finish. It was observed that a number of the grates were broken.

EXHIBIT 4. VIEW OF MULTI-LAYERED AND BROKEN GUTTER DRAIN GRATES

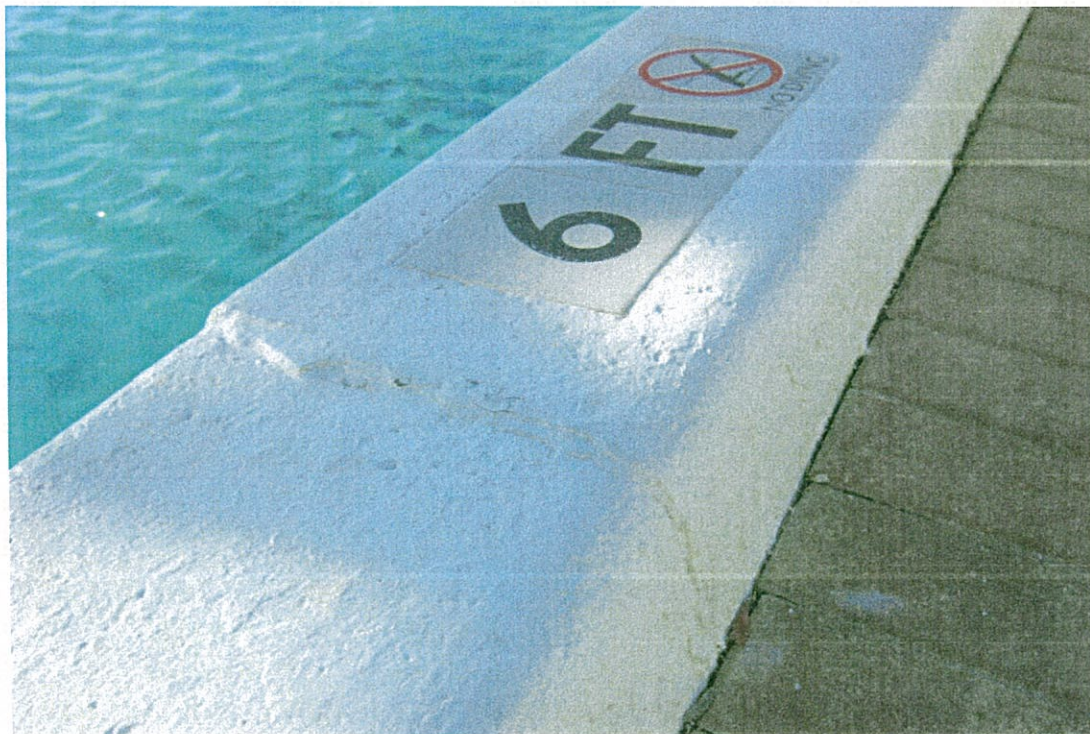
EXHIBIT 8. VIEW OF REPAIRED DISBONDED COPING STONE

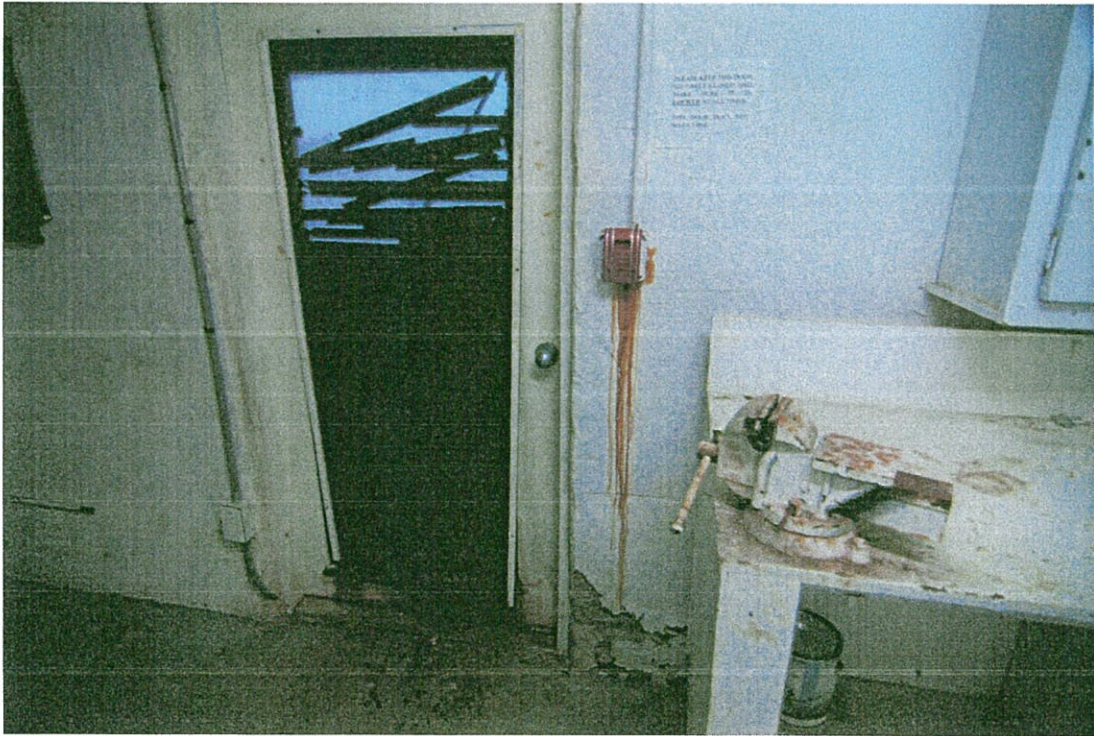
21. Generally, the pool equipment was in "fair" to "good" condition and appeared to be functioning in accordance with the intended purposes.
22. You directed me to an enclosed area at the entrance to the parking garage at the North end of the pool and deck. Examination of the structural components of this area revealed deterioration of the concrete around the pass door opening and deterioration of the pass door.

EXHIBIT 17. VIEW OF DETERIORATED PASS DOOR AND SPALLED CONCRETE, ENCLOSED AREA AT ENTRANCE TO PARKING GARAGE

- e. The spalled concrete at the pass door requires repair and the pass door requires replacement.
