Subject: Three Thousand South Ocean Pool Evaluation Report

Sinclair Engineering Company performed a visual, non-destructive inspection of the Three Thousand South Ocean pool and related items in your presence on April 2, 2014.

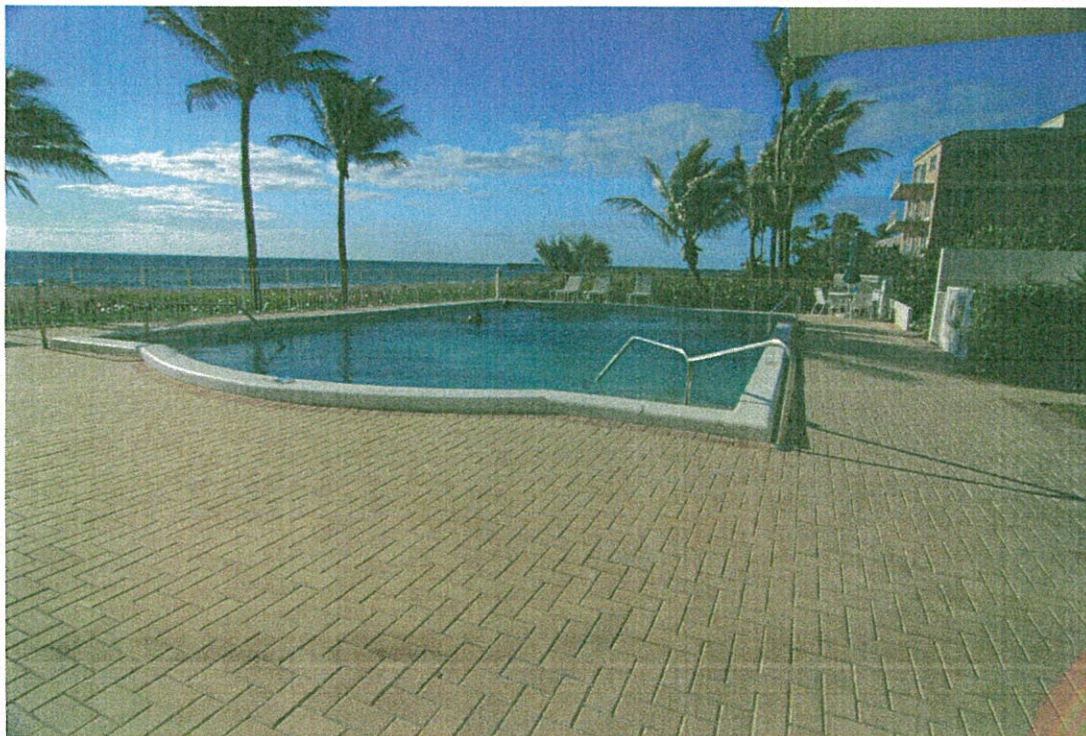
EXHIBIT 1. OVERALL VIEW OF POOL AND DECK LOOKING SOUTHEAST

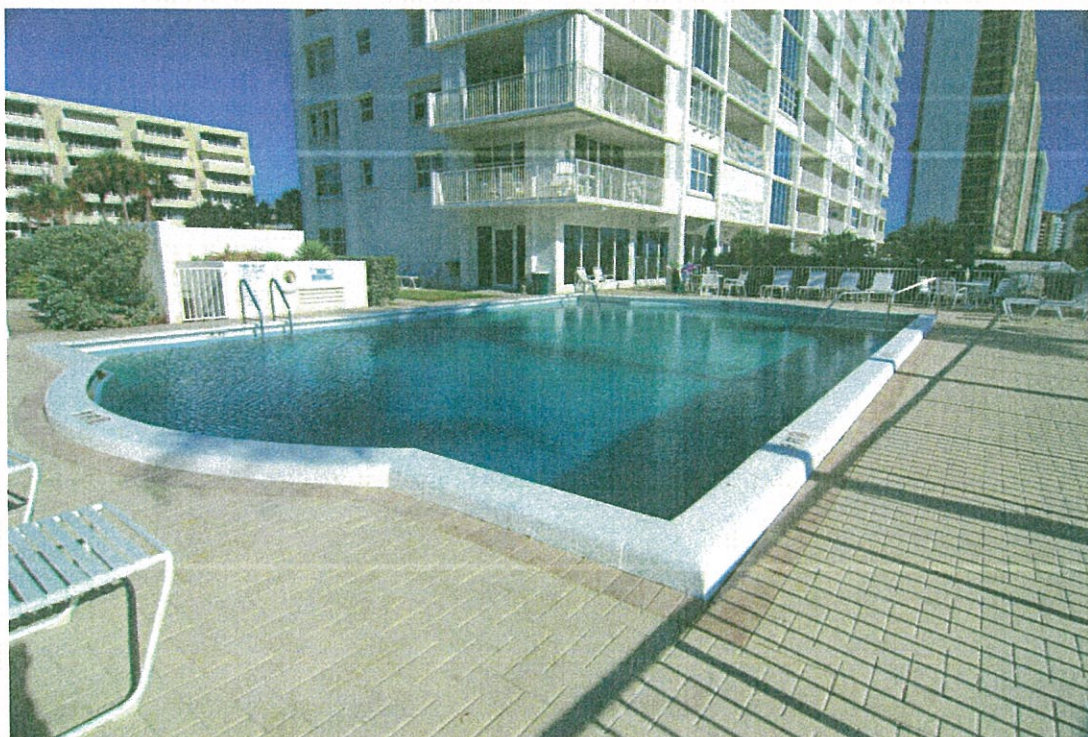
EXHIBIT 2. OVERALL VIEW OF POOL AND DECK LOOKING NORTHWEST

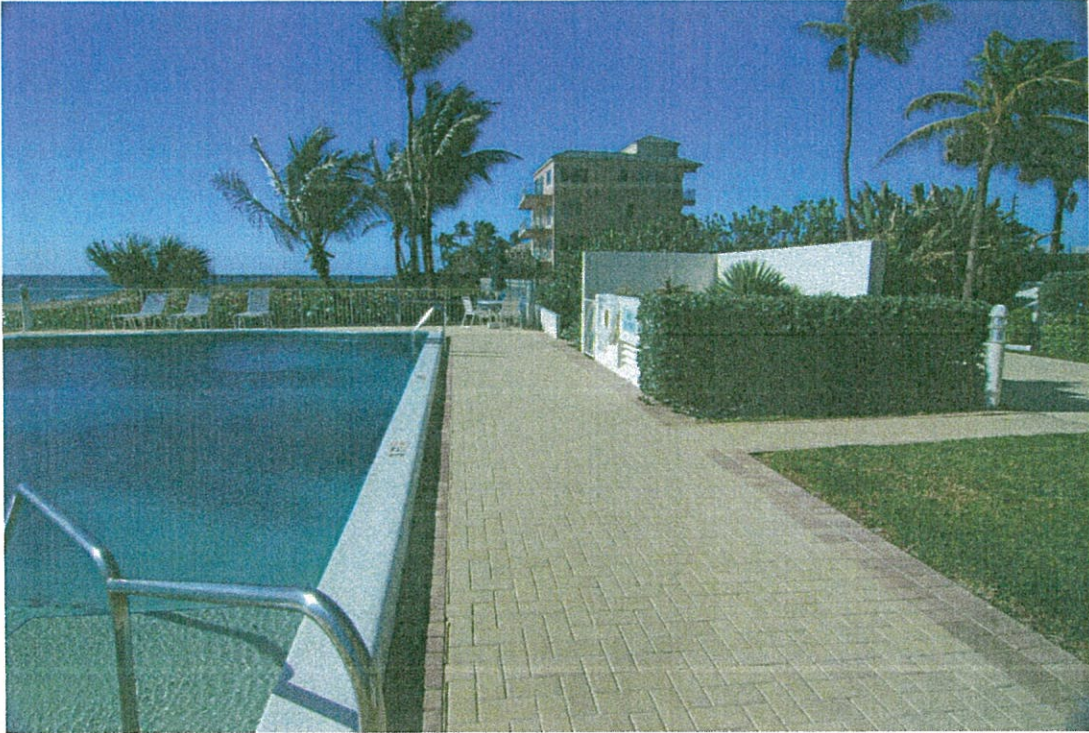
11. Examination of the pool equipment building, located on the West side of the pool, revealed that it was generally constructed of concrete block and stucco with a flat roof. The floor level of the building was approximately 5'-6' below the level of the pool deck. The pool equipment building was generally in "good" condition, being free of visible evidence of differential settlement or structural deterioration.

EXHIBIT 11. VIEW OF POOL, DECK AND POOL EQUIPMENT BUILDING LOOKING SOUTH

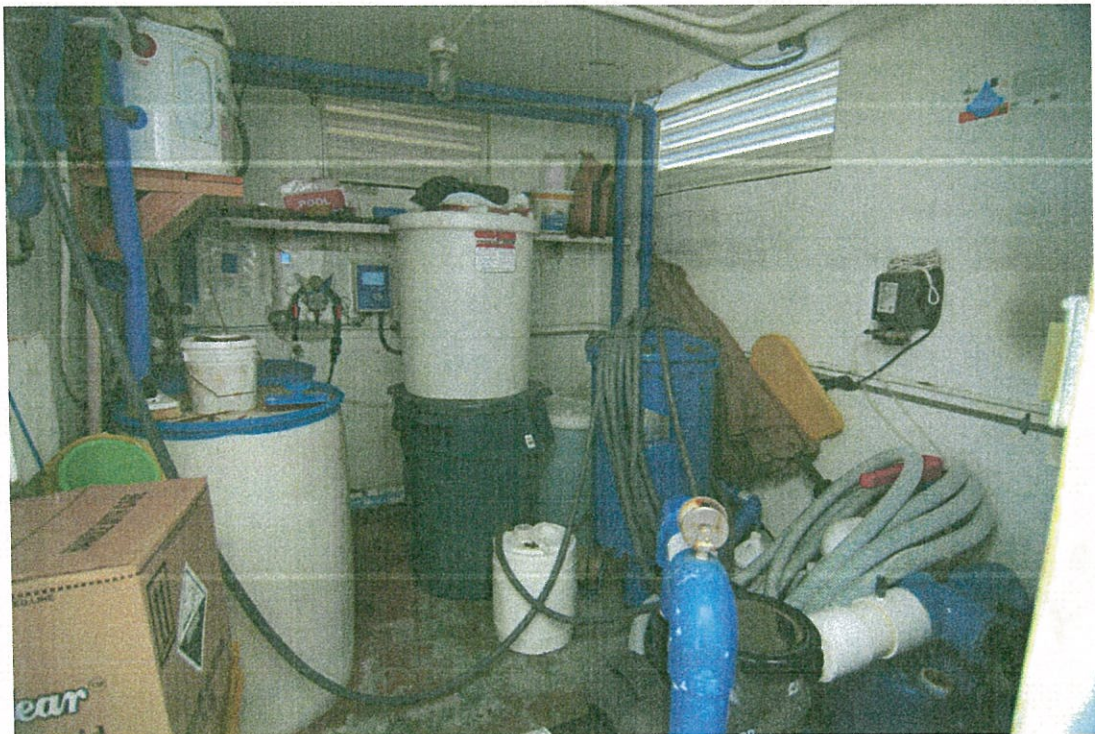
15. Examination of the electrical panelboard in the pool equipment building revealed that several of the wires had been installed in a poor workmanship manner. It was also noted that the panelboard cabinet was corroded.

EXHIBIT 12. VIEW OF INTERIOR OF POOL EQUIPMENT BUILDING

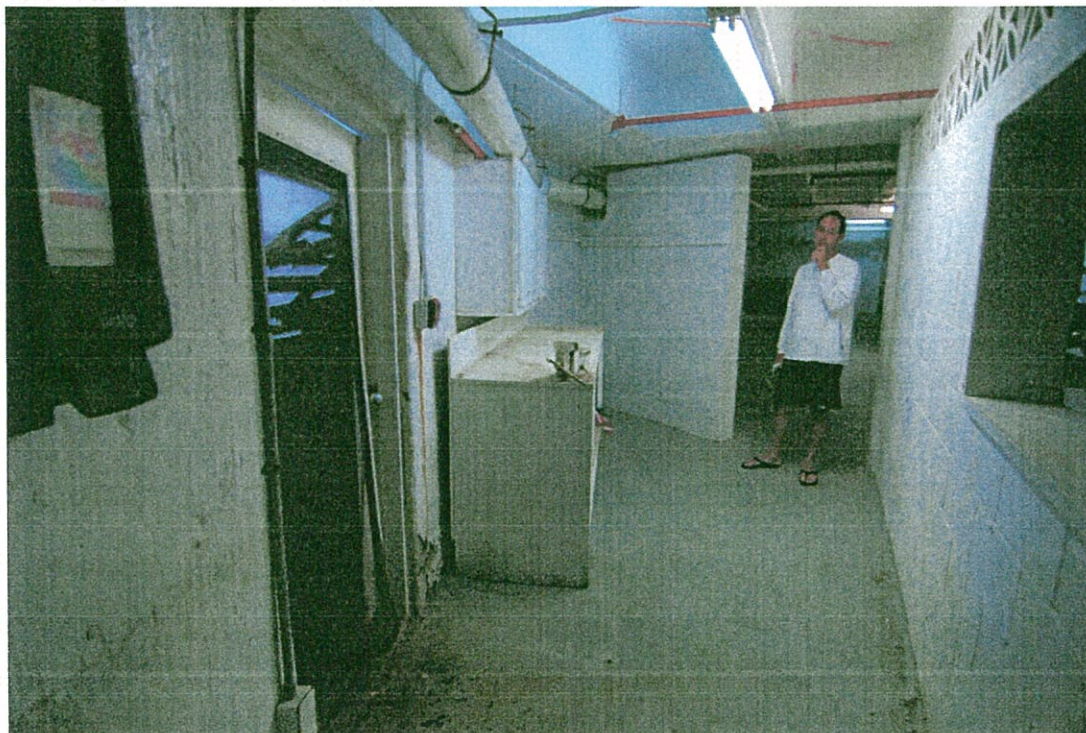
21. Generally, the pool equipment was in "fair" to "good" condition and appeared to be functioning in accordance with the intended purposes.
22. You directed me to an enclosed area at the entrance to the parking garage at the North end of the pool and deck. Examination of the structural components of this area revealed deterioration of the concrete around the pass door opening and deterioration of the pass door.

EXHIBIT 15. VIEW OF ENCLOSED AREA AT ENTRANCE TO PARKING GARAGE ADJACENT TO NORTH END OF POOL AND DECK

- e. The spalled concrete at the pass door requires repair and the pass door requires replacement.

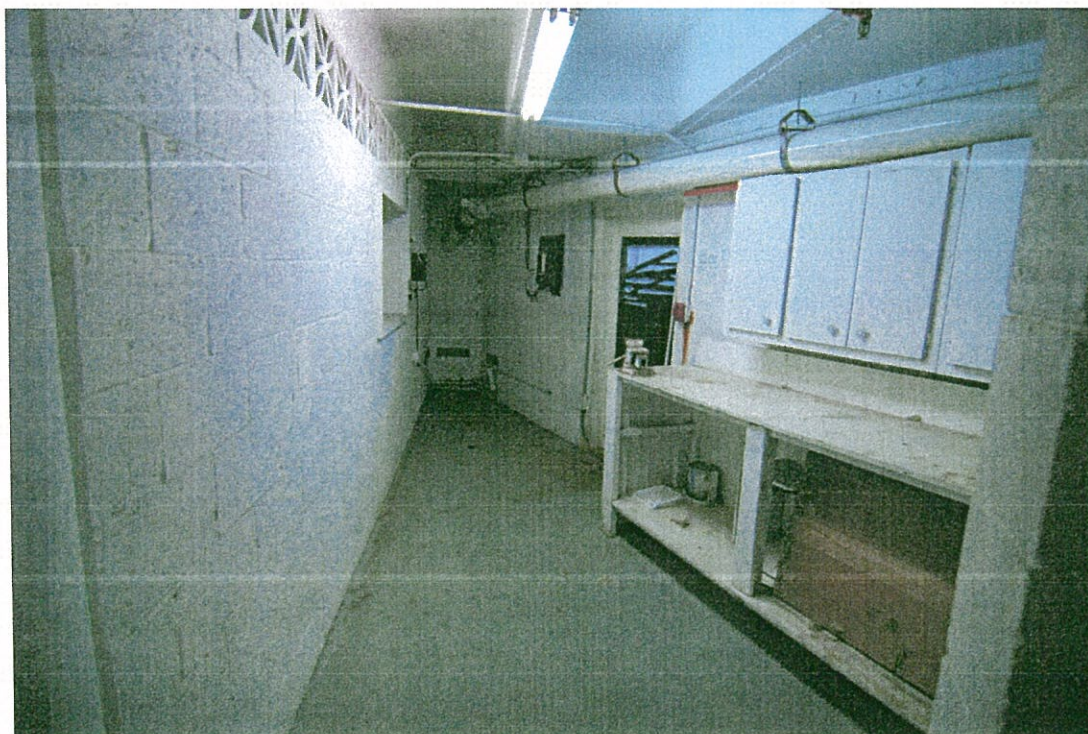
EXHIBIT 16. ALTERNATE VIEW OF ENCLOSED AREA AT ENTRANCE TO PARKING GARAGE ADJACENT TO NORTH END OF POOL AND DECK
