Subject: Three Thousand South Ocean Pool Evaluation Report

Sinclair Engineering Company performed a visual, non-destructive inspection of the Three Thousand South Ocean pool and related items in your presence on April 2, 2014.

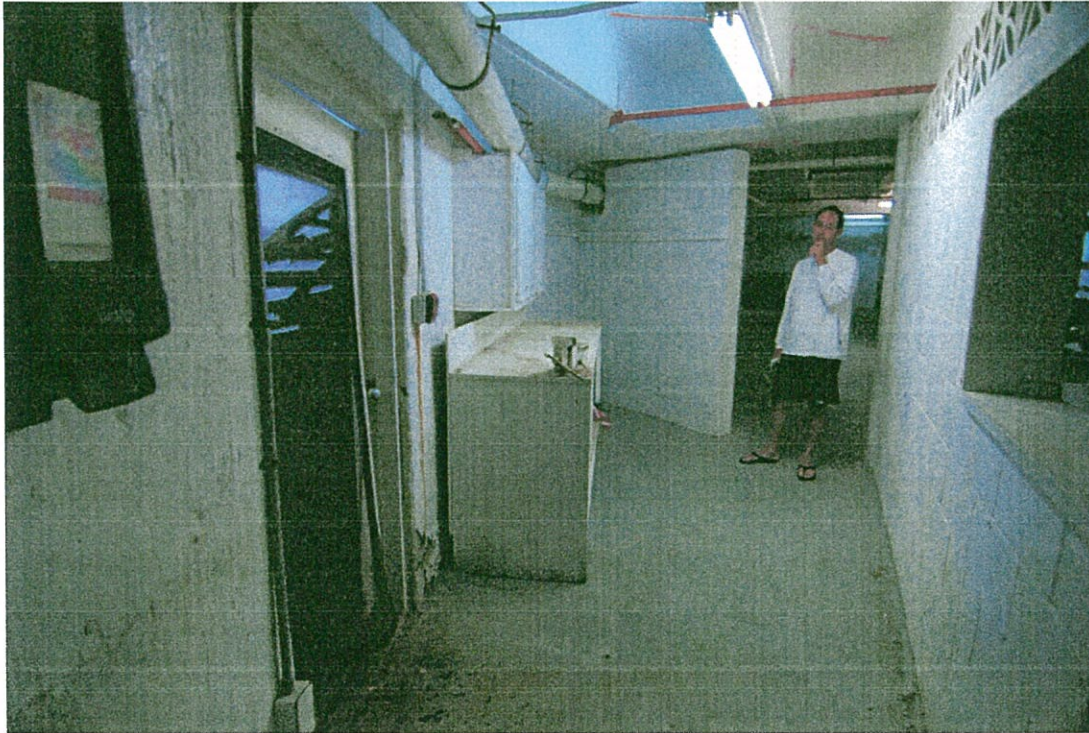
EXHIBIT 15. VIEW OF ENCLOSED AREA AT ENTRANCE TO PARKING GARAGE ADJACENT TO NORTH END OF POOL AND DECK

21. Generally, the pool equipment was in "fair" to "good" condition and appeared to be functioning in accordance with the intended purposes.
22. You directed me to an enclosed area at the entrance to the parking garage at the North end of the pool and deck. Examination of the structural components of this area revealed deterioration of the concrete around the pass door opening and deterioration of the pass door.

- e. The spalled concrete at the pass door requires repair and the pass door requires replacement.
